CORROSION AUTOPSY OF A STRUCTURALLY UNSOUND BRIDGE DECK

CA-HY-MR-5116-8-72-41

Prepared in Cooperation with the U.S. Department of Transportation, Federal Highway Administration November, 1972

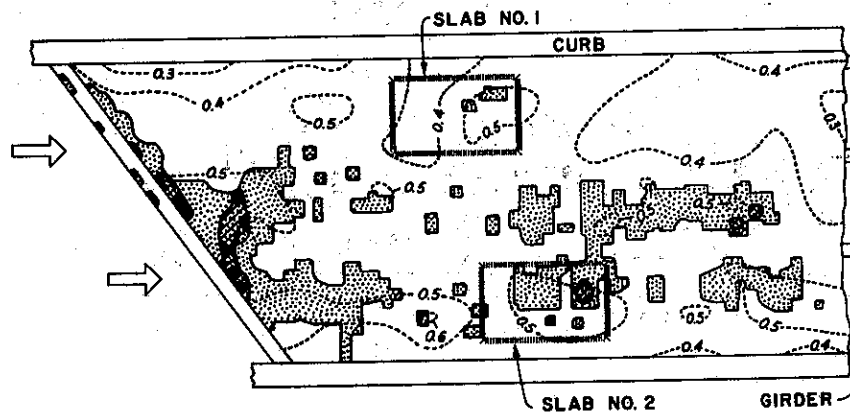
Figure 1. Part of Span 1

Figures 1 and 2, show that the high potential measurements on nearly the whole deck surface indicated a massive area of active corrosion of the steel. Although not shown on Figures 1 and 2, visual observations of the steel during the concrete removal show significant areas of rusting steel even though the concrete in these areas showed no indication of spalling or delamination.

For the entire bridge deck about 94% of all of the halfcell potentials of the steel were in the active or corroding range. In contrast, approximately 20% of the deck area was found to be delaminated or to have undersurface concrete fractures at the top layer of the steel.

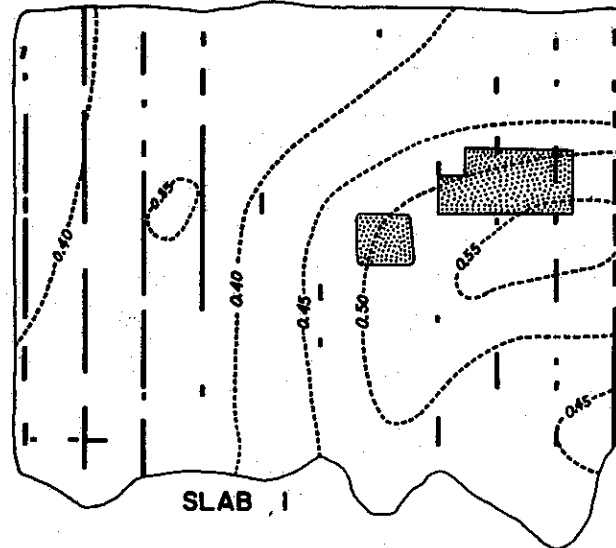
Figure 3. Slab showing little delamination.

Figure 3, shows the electrical potentials and concrete delamination that was measured on the relatively good slab. All of the halfcell potentials are in the active range of -0.35 to -0.55 volts and denote the likelihood of significant corrosion of the steel. On Figures 3, 4, and 5 the locations of steel that had visible rust was plotted as solid lines. If the top mat of reinforcing had no rust, it was not shown.

Shown on Figure 3 is an undersurface delamination that apparently is in a location of unrusted steel. Because this area of concrete still had the epoxy-aggregate membrane on the surface, it is believed that the hollow sound that caused a recording of a concrete delamination might have been the result of disbonding between the epoxy membrane and the underlying concrete surface.

As shown by Figures 3, 4, and 5, the relationship between rusted steel and concrete delaminations can be poor. This is not to say that the corroding steel does not cause delaminations, but

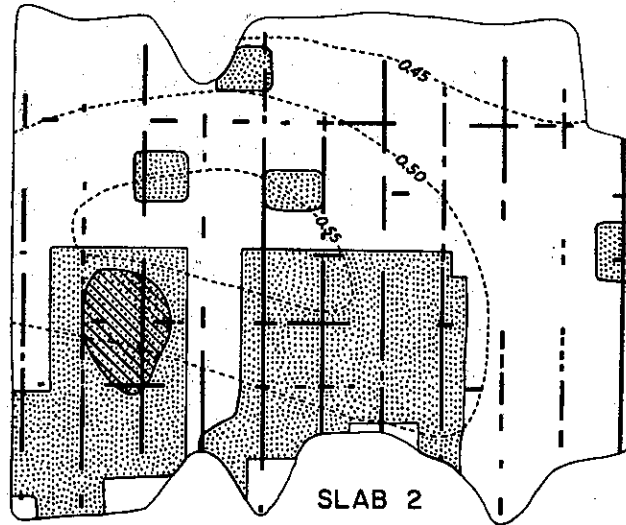
Figure 4. Slab showing severe cracking of soffit and epoxy patches.

it does indicate that the amount of rust that forms on steel causing a spall can be highly variable. It is obvious that the sounding of concrete only relates to the condition of the concrete and not necessarily to the condition of the steel.

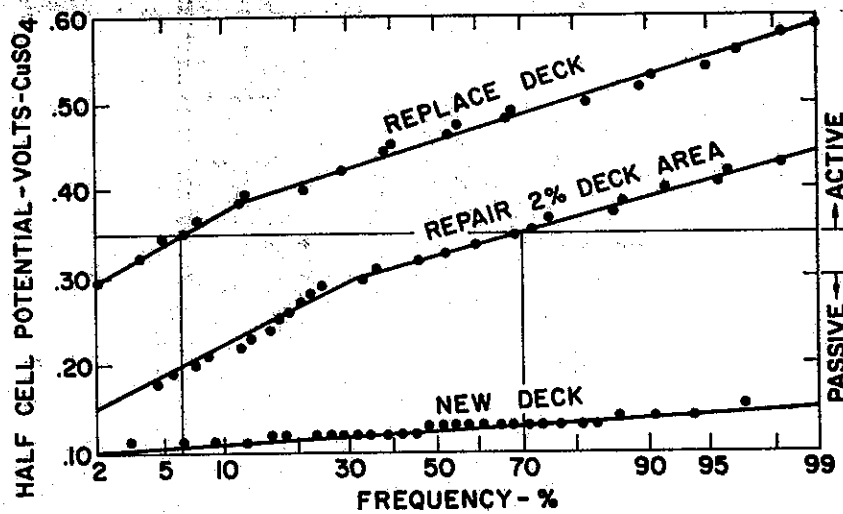
Figure 6. Distribution of halfcell potentials.

To relate the halfcell potential measurements to the observed condition of the bridge, Figure 6, shows the cumulative frequency distribution on three bridges. The distribution curve "Replace Deck" is for the bridge under investigation, while the distribution curve for another bridge is titled "Repair 2% Deck Area". For the bridge deck that required replacement, about 94% of all of the potential measurements made showed that the steel was active (more negative than -0.35 volts, Cu/CuSO_4) or corroding. For the deck that was repaired, only 30% of the measurements showed active halfcell potentials, and the new deck had no measured active potentials.

The data shown on Figure 6 may reflect a means for "logging" the condition of a bridge according to the percentage of active or passive potentials. However the distribution curve can have a "break", therefore one must exercise caution in mathematically calculating a mean or standard deviation for the halfcell potentials.
